Investment Decision Pack A9.09A – Overhead Line (OHL) Towers and Foundations December 2019

Engineering Justification Paper; Non-Load Related Overhead Lines: Non-lead Assets (Towers and Foundations)			
Asset Family	Overhead Line (OHL) Towers and Foundations		
Primary Investment Driver	Asset Health (Towers – Non-Lead Assets)		
Reference	A9.09		
Output Asset Types	Non-Lead asset work <ul style="list-style-type: none"> Tower Steelwork Tower Painting Tower Foundations (Condition monitoring, condition assessment, plant status work & maintenance are not covered in this report)		
Cost (T2 Outputs)	£199.7m		
Delivery Year(s)	2021 – 2026		
Reporting Table	C2.2A		
Outputs included in RIIO-T1 Business Plan	Yes		
Spend Apportionment (T2 schemes proposal)	T1	T2	T3
	£2.304m	£194.640m	£2.778m
Completion of RIIO-T1 schemes		£1.282m	
Development of schemes to deliver output beyond T2		£1.011m	
Total	£2.304m	£196.934m	£2.778m

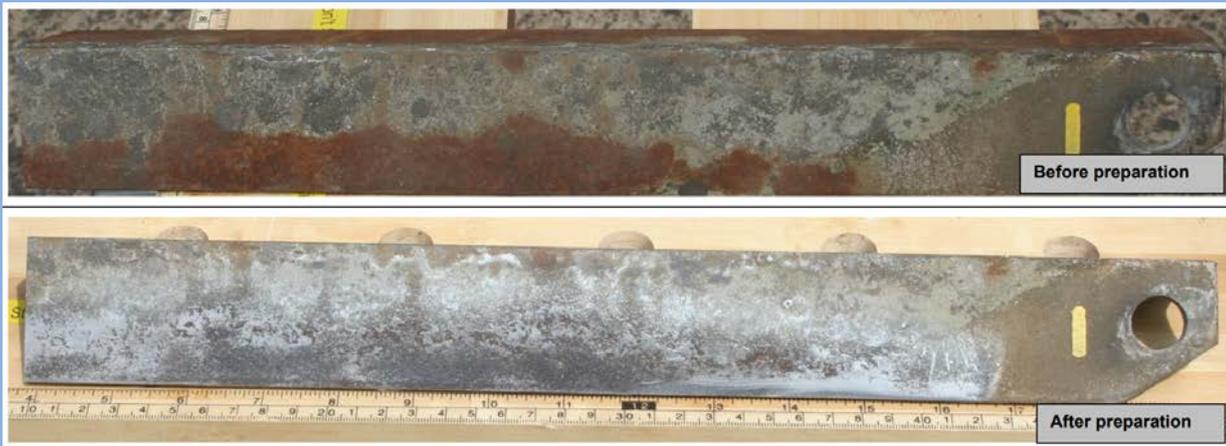
Figure 3. Comparison photos showing Grade 4 recovery preparation

Being able to avoid replacement of corroded members is dependent on us being able to recover the bars and re-coat them to prevent further loss of section. This has become possible for Grade 4 steelwork as a result of a successful innovation project (see box below).

At the time of our RIIO-T1 submission, we were part-way through an innovation project into an enhanced coating system that would allow the recovery of Grade 4 steelwork. Our RIIO-T1 submission assumed that we would be able to recover 60% of Grade 4 steelwork, with the remaining 40% of Grade 4 together with all Grade 5 and 6 steelwork being replaced. This innovation project has subsequently been implemented, and we are now forecasting to recover 100% of Grade 4 steelwork.

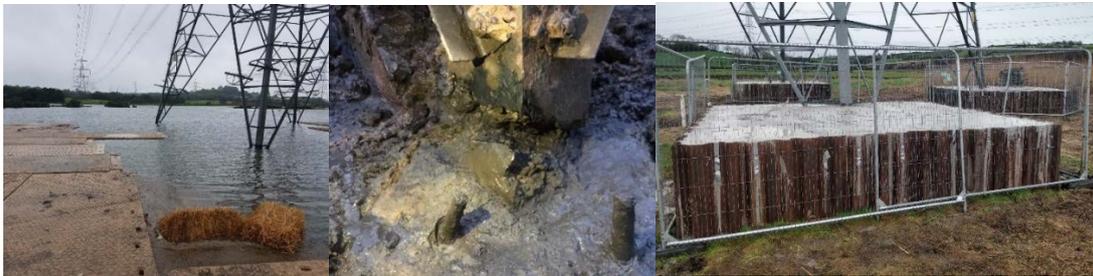
Regular flooded conditions the tower was subjected to

Disconnection of the tower leg to the foundation

Consequently, emergency works were carried out to make both towers safe using a temporary mass-infilled concrete solution until system availability permits replacement of both towers.

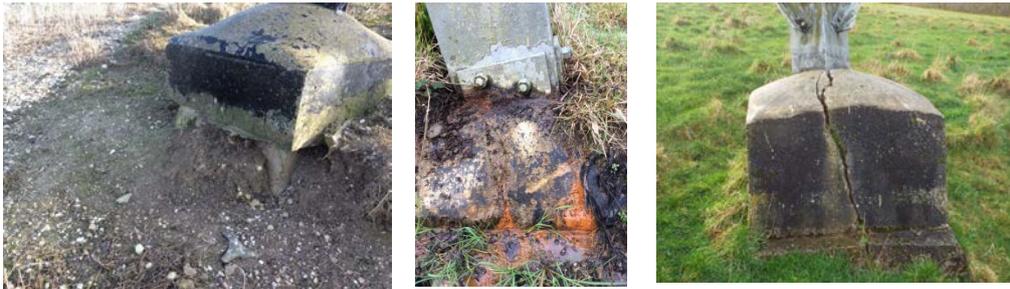
Every OHL route is walked and visually inspected every 12 months, paying particular attention to critical assets associated with the overall OHL system – including above ground aspects of the foundations (for example muff concrete and surface pile caps). The inspections will also use verticality checks where there could be issues with the vertical alignment of the tower in both planes – which can be symptomatic of issues with the foundations (including settlement, embedded steelwork corrosion/displacement, concrete deterioration etc.). When such a defect is identified, it is recorded, validated and reported for further inspection to be undertaken. Some example photos of typically reported defects can be seen in Figure 12 below:

Figure 11. L-R – a) Exposed Foundation, b) Corrosion of Embedded Steelwork, and; c) Significant Cracking through Muff Concrete
